Smart Performance Program

Online Vibration Monitoring on Tube Mills in the Cement Industry

Customer: Spenner Zement, Erwitte (Germany)

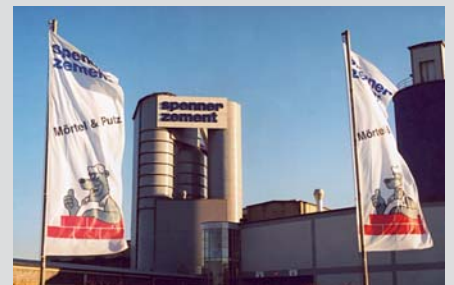
Technical Information about the Plant

Tube mill (tube grinding)

1 MW (triple shaft helical gearbox)

Length: 8 m

Diametre: 3 m

Speed: 15 RPM

The customer has several cement mills (tube mills) at its location in Erwitte, Germany, and runs its production at full capacity despite the difficult market conditions in the sector. Despite monitoring with a temperature sensor, in 2002 one of the mills had to be shut down for three weeks because of a gearbox damage. The gearbox showed already heavy deterioration and had to undergo cost-intensive reparings.

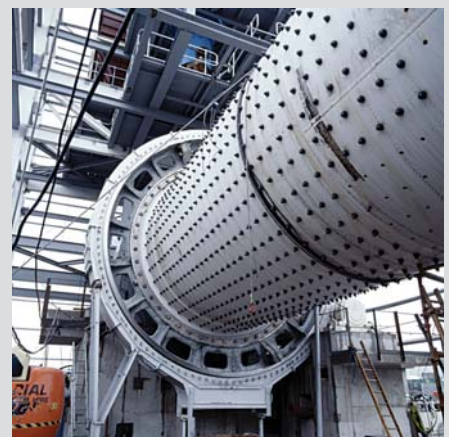
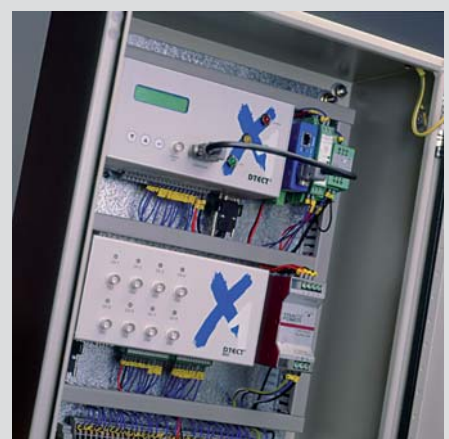
3 sensors at the gearbox:
Monitoring of the gear bearings and gear mesh

2 sensors at the reduction gear:
Monitoring of gear rim and pinion

F'IS installed the online monitoring system FAG DTECT X1 with five sensors at the main gearbox and reduction gear. Whilst F'IS experts supported the customer for three months in analysing the data, Spenner employees were trained in vibration monitoring and they started to operate the system on their own. In 2004, the FAG DTECT X1 detected a tooth damage in the gear mesh which was confirmed after a visual inspection by Spenner Zement. The gearbox was replaced during a planned shutdown. At the same time, abrasion on the tothing of the layshaft gear pinion was identified and removed.
